# **AFFORDABLE MONSOON RAIN MITIGATION MEASURES IN THE WORLD HERITAGE SITE OF MOENJODARO, PAKISTAN**

Enrico Fodde<sup>1</sup>, Muhammad Safdar Khan<sup>2</sup>

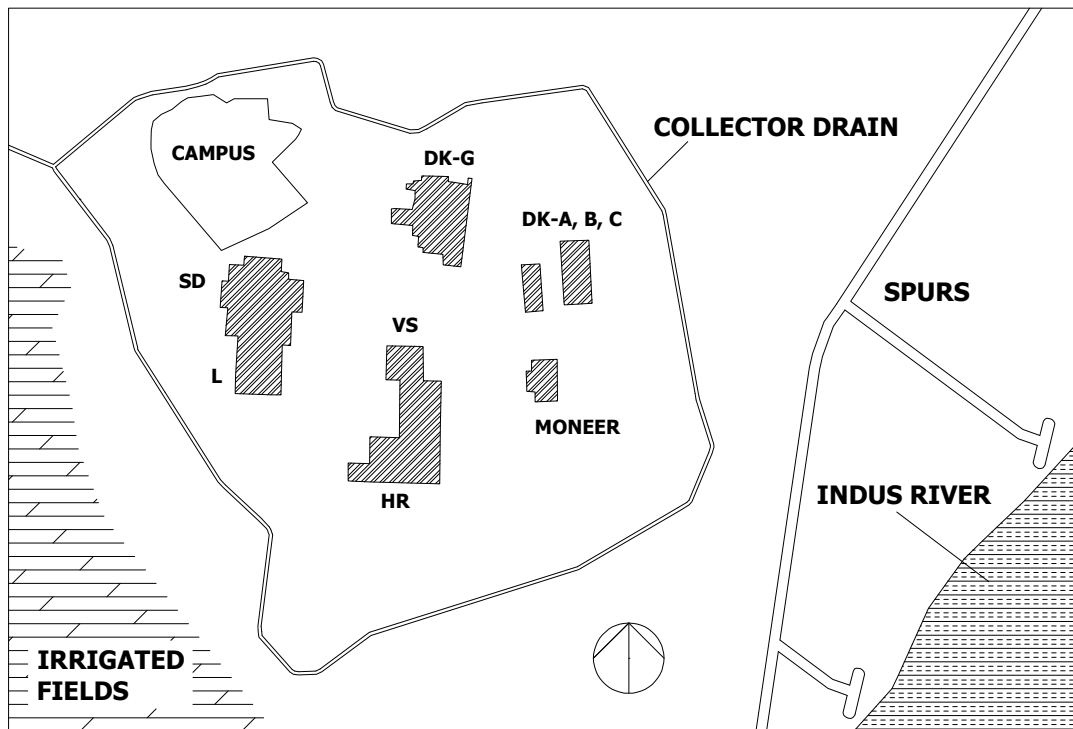
**Fig. 1** Schematic map of Moenjodaro showing outline of prominent excavated areas within the collector drain, spurs location, and proximity to the river Indus and to irrigated fields

The World Heritage site of Moenjodaro is located in Sind about 400Km north of Karachi and 32km south of Larkana. The site lays on the bank of the river Indus (Figure 1) and is believed to have flourished from 2350 to 1800 BC<sup>1</sup>. Moenjodaro was one of the main centres of the Harappan civilization and it was constructed with two building materials: mud brick (10x20x40cm), and fired brick (6.3x13.4x27.9cm) bonded with mud mortar<sup>2</sup>. In contrast with other settlements of the same period, the Harappan cities were built mostly with fired brick whilst little use was made of mud brick as walling material. According to Cooper and Dawson (1989) this is due to the fact that the site is built on an alluvial floodplain, and to stronger resistance of fired brick to floods.

The river Indus flows at about 1Km east of the ruins of Moenjodaro, with floods being a common feature. According to the findings of Boekwijt (1979), the site is situated at 47m (AMSL) while the maximum flood level of the river Indus near the site reaches about 50m (AMSL). This is why the site was protected from river flood damage with five spurs and a dam<sup>9</sup> as visible in Figure 1 (see section 5.1).

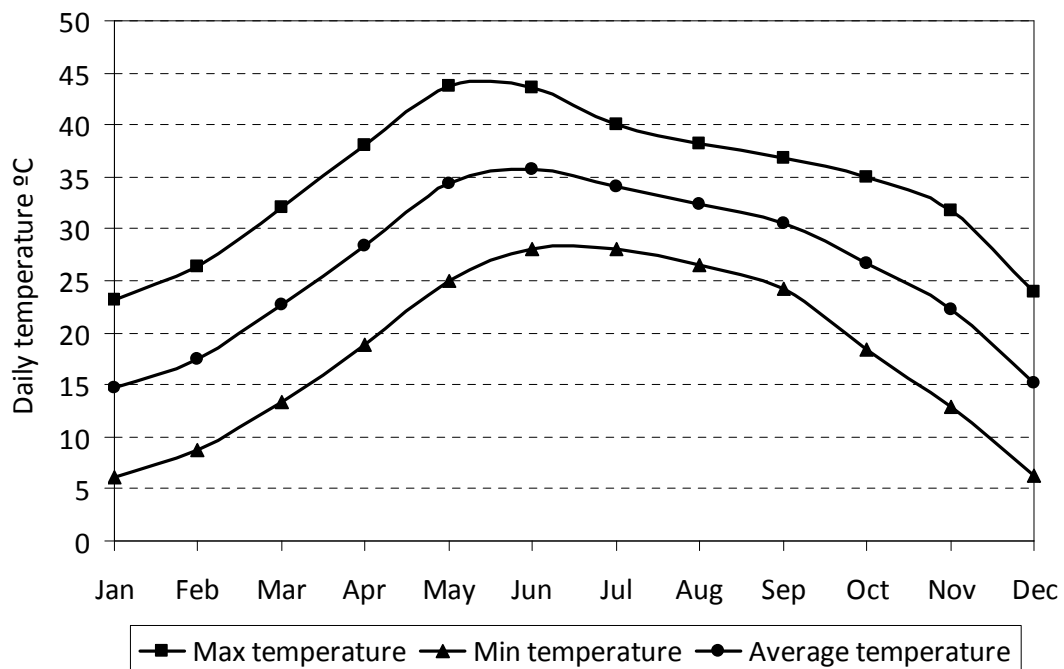
**Fig. 2** Climate on site. Daily temperatures as averaged over the period 1985-2004. More recent data is not available

Climate on the site is represented by extreme temperature that can reach 47°C in May-June (Figure 2). Rainwater run-off is a major threat to Moenjodaro, monsoon precipitation being quite intense in June. For instance, the study of 2004 rainfall data shows that precipitation concentrates in the winter (19.5mm between December and January) and during the monsoon season (7.1mm in June). Rainfall can be particularly intense during the monsoon period: it was calculated that a heavy storm of 60mm can take place easily in the site (Boekwijt 1979) and more recently, more than 200mm were observed in two days (Briscoe 1997).

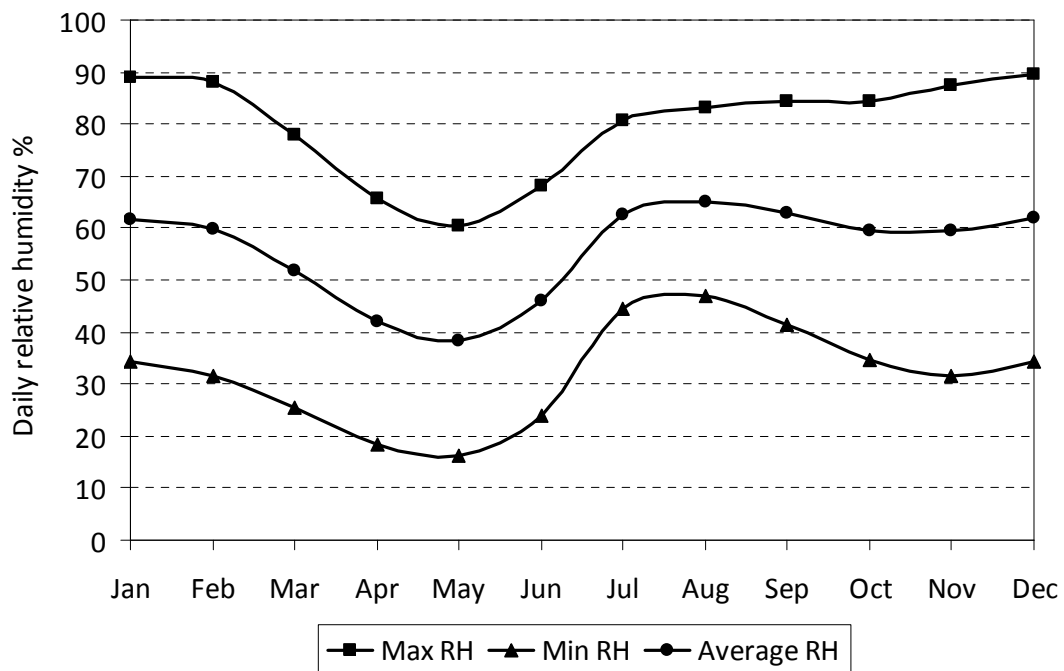
**Fig. 3 Daily relative humidity on site as averaged over the period 1985-2004. More recent data is not available**

Another influential aspect in Moenjodaro is represented by atmospheric moisture (or dew) and RH (monitored at the site, see Figure 3): sodium sulphate, the most common salt in the site, is hygroscopic and not only collects water from rising damp, but also from the air. A more detailed explanation of this phenomenon is given in section 4.6 and in Fodde (2008).

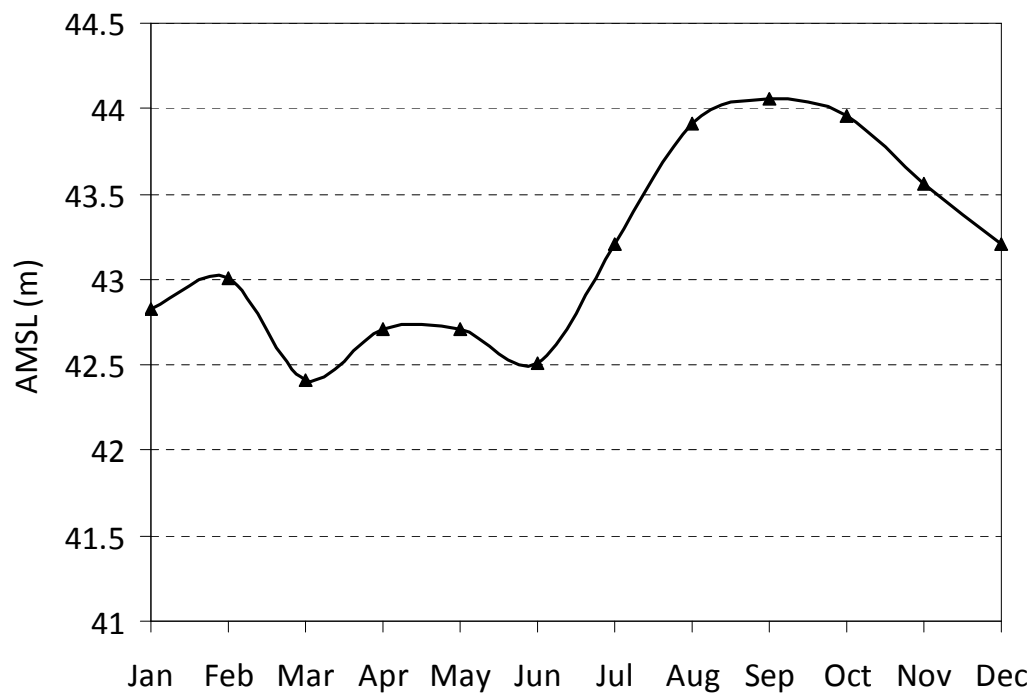
**Fig. 4 Average water table over the period 1995-2004. Monthly readings taken from piezometer No. 8, AMSL 47.46. It should be noted that the changes reflect the precipitation values.**

Another threat is represented by the rise in sub-soil water. The ground water table varies both in winter and summer due to which the capillary rise of water in the brickwork reaches up to 51m (AMSL, above mean sea level). The general water table as recorded during 1990-2000 varies from about 41-45m (AMSL). In 1972 a massive tubewells project was proposed with the aim of lowering the water table (Figure 4) and of reducing capillarity rise damage. In 1996 the running of tubewells was considered expensive due to the amount of power needed and the option of solar energy was considered. However, no action was taken and the tubewells started to be switched off and, since no maintenance was carried out, their decline followed.

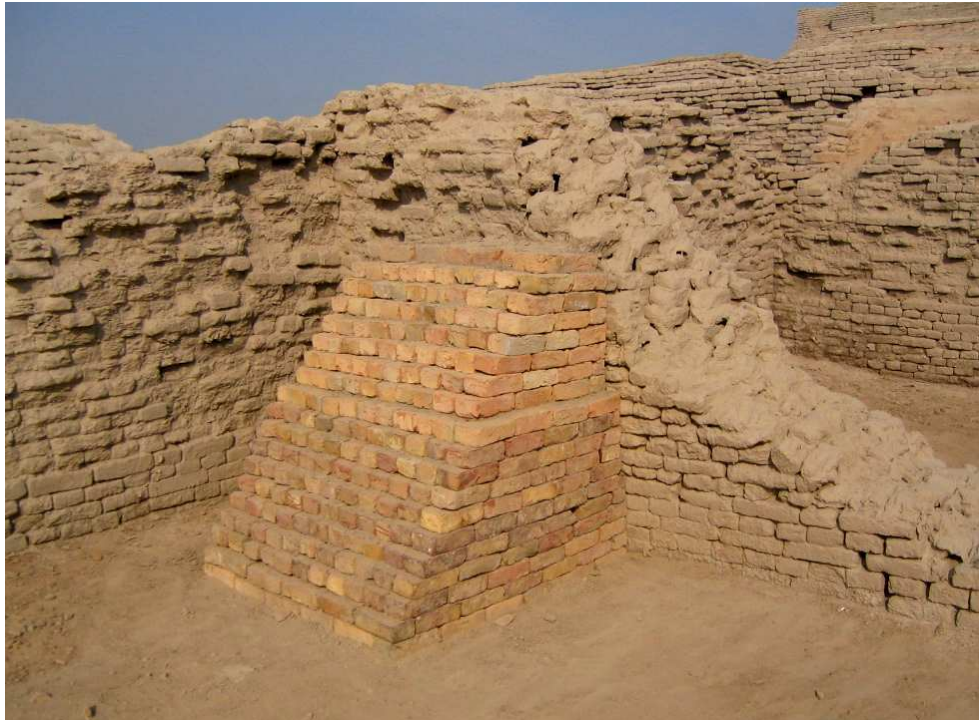
**Fig. 5 Buttresses are constructed as measures against walls that are leaning for the combined effect of thermal stress and water ponding (SD area)**

One of the most ancient mitigation systems at use in the site is represented by buttresses made with fired brick and mud mortar (Figure 5). This method dates back to the Indus valley civilization period when it was employed for preventing leaning walls from collapsing (Briscoe 1997), most probably due to reasons related to heavy rain and ponding.

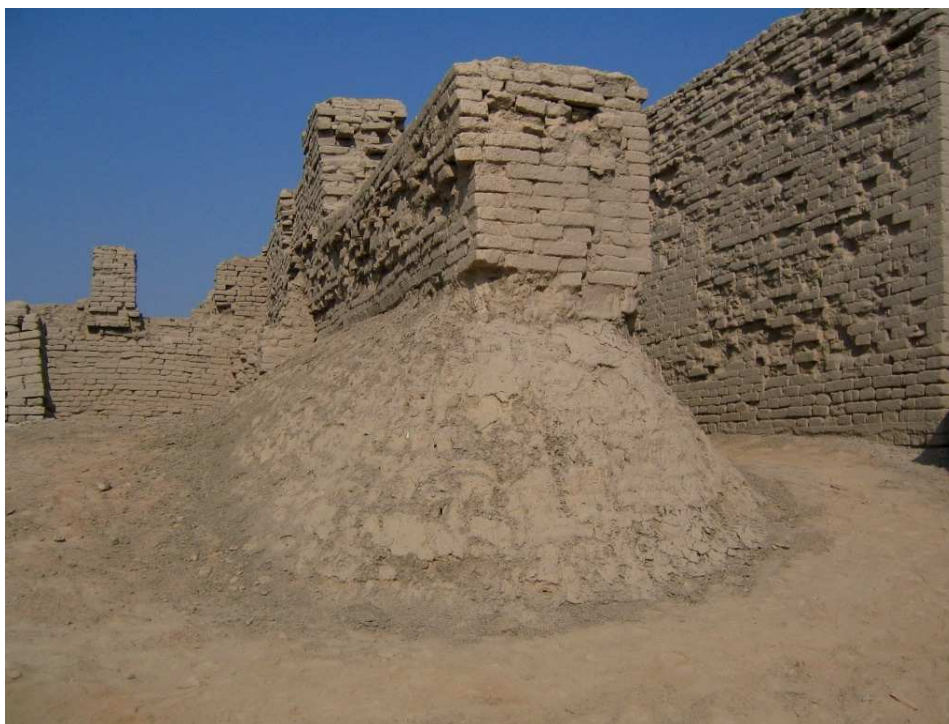
**Fig. 6 Mud *pushtas* are employed in Moenjodaro as structural measure against coving (SD area)**

Another interesting system against erosional loss is that of mud *pushtas* (Figure 6), which are employed also in neighbouring villages for the protection of vernacular earthen construction. The technique consists in the building of a continuous mud brick buttress around the perimeter of the wall. Compared to fired brick buttresses, mud *pushtas* have the advantage of being more flexible, less rigid, and accommodating more easily to uneven walls. One relevant aspect is that *pushtas* need to be limited in width in order not to be too disruptive (Briscoe 1997).

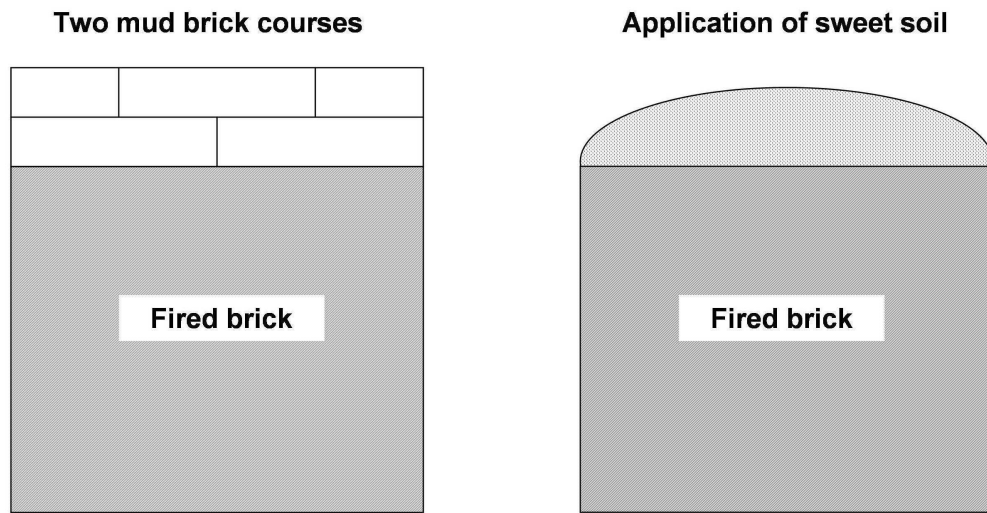
**Fig. 7 Two types of wall capping are in use in the site: the one on the right hand side being used as urgent measure because faster**

Some of the horizontal wall surfaces are so wide that proper protection is needed against monsoon precipitation (Figure 7). Wall capping is widely applied in the site since 1956. This is confirmed by a survey carried out by the authors in the area called DK-G South on 493 walls<sup>7</sup> showing that wall capping with two courses of mud brick is present on 86.6% of the walls. The final outline of the top part of the walls follows that of the 'as found' state. The idea behind such soft capping is that of reversibility and of allowing regular maintenance through replacement of eroded parts.

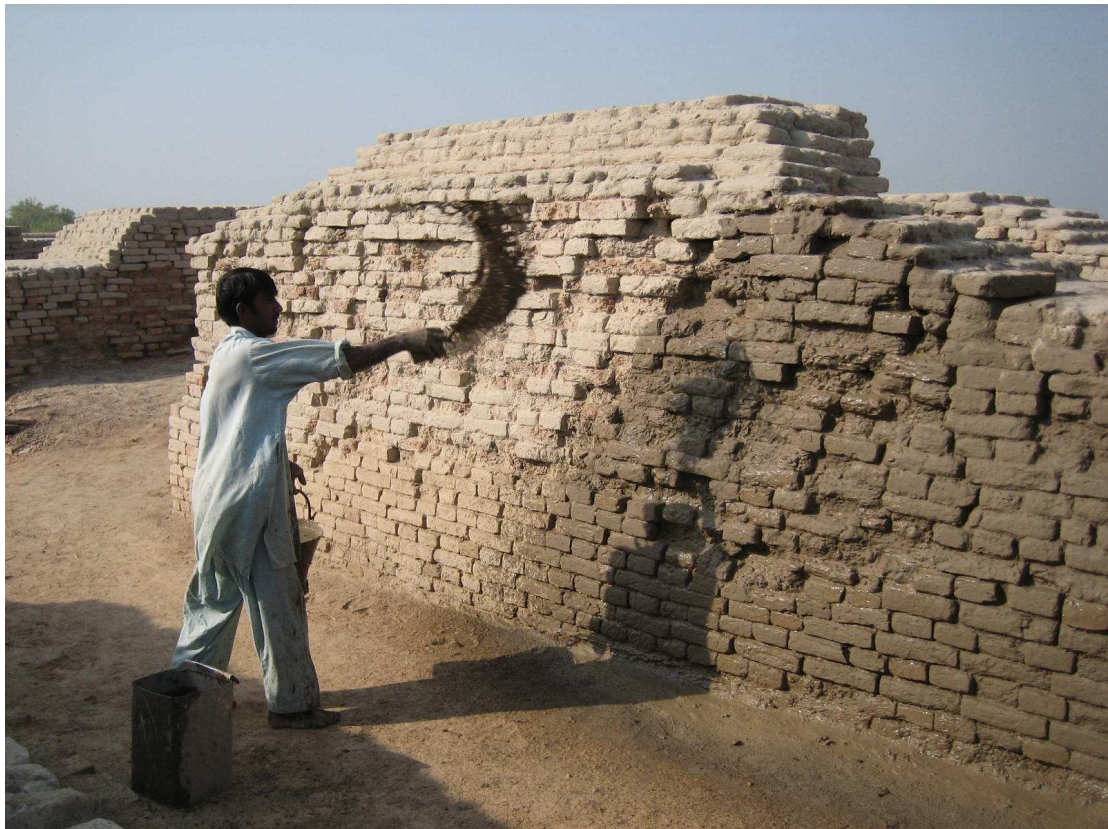
**Fig. 8 Mud slurring, or mud washing, is provided to the whole structure with simple devices. This is done annually as a measure against salt weathering, but also as a measure against heavy rain**

Mud slurring, the expression employed by local craftsmen and conservators for mud washing, is carried out by creating a continuous layer of a 'mud paint' that covers the entire wall<sup>8</sup>, capping included (Figure 8). It is employed in the site as conservation measure against salts weathering, but it provides also protection against heavy rain attack. The technique is employed extensively and this is confirmed by a 2005 survey in DK-G South area on 493 walls, with total length of 2954m, showing that 90.3% of the walls are mud slurried. The application of mud slurry is controversial since 1993 when it was used for the first time in Moenjodaro. Since then the site changed from the typical red colour of fired brick to a brown which is more typical of mud brick. For such reason, uninformed visitors can be misled and believe that the site was actually built with mud brick only. However, according to Jansen (2003), the mud slurry or wash has a positive effect because it *'...brings back the original colour to the walls which were rendered with soil some 4500 years ago.'*

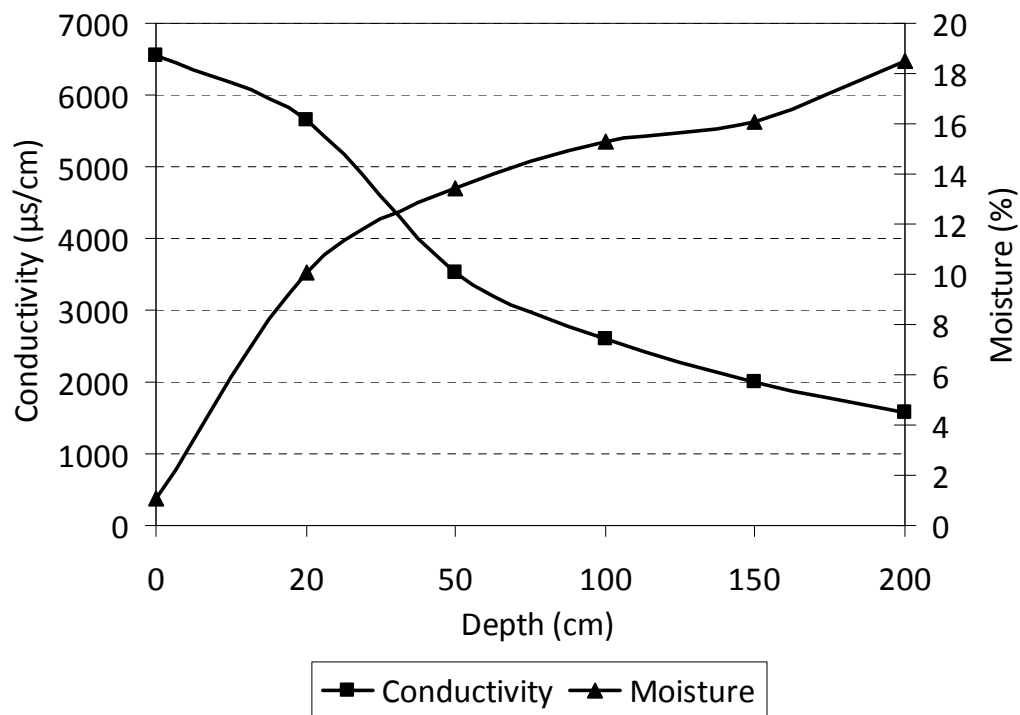
**Fig. 9 Soluble salts content (conductivity) and moisture and as measured in bore hole No 2, next to piezometre No 8. Monthly readings averaged over the period 1995-2004**

Weathering takes place especially at the wall base and this is due to the fact that Moenjodaro's ground has high soluble salts content. This is confirmed by Figure 9 which provides the ground soluble salts and moisture content from a depth of 200 cm to 0cm (surface). The diagramme shows that whilst sub soil moisture content

increases with the depth of the soil itself, soluble salts tend to increase towards the ground surface and this is due both to capillary action and to an increase in temperature. The obvious effect is that capillarity rise of water and salts solution has an influence on the weathering of walls.

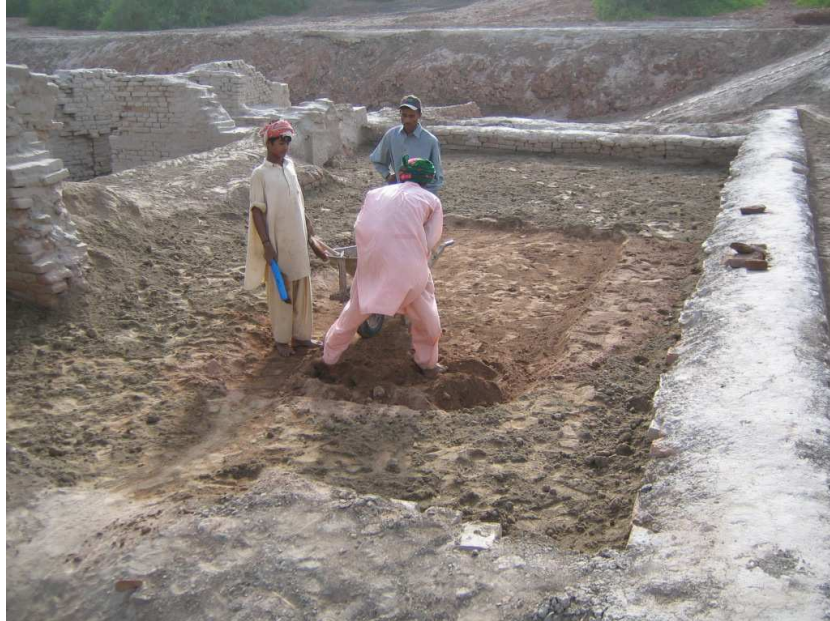
**Fig. 11 Creation of shallow ponding (DKG-South area)**

Draining rooms with no openings is one of the most difficult tasks. Such rooms tend to collect water that cannot be diverted otherwise and in such case the only non-disruptive measure is that of shallow ponding (Figures 10 and 11). This is undertaken by creating a depression or pool in the middle of the room so that water is eliminated by evaporation. Shallow trenching is made by digging a V shaped trench that has the aim of collecting water and diverting it to drainage areas (Briscoe 1997). When dealing with emergency conservation, low barriers are made by compacting loose soil in order to divert run-off water away from walls. Otherwise they are made with mud brick and seldom with fired brick.

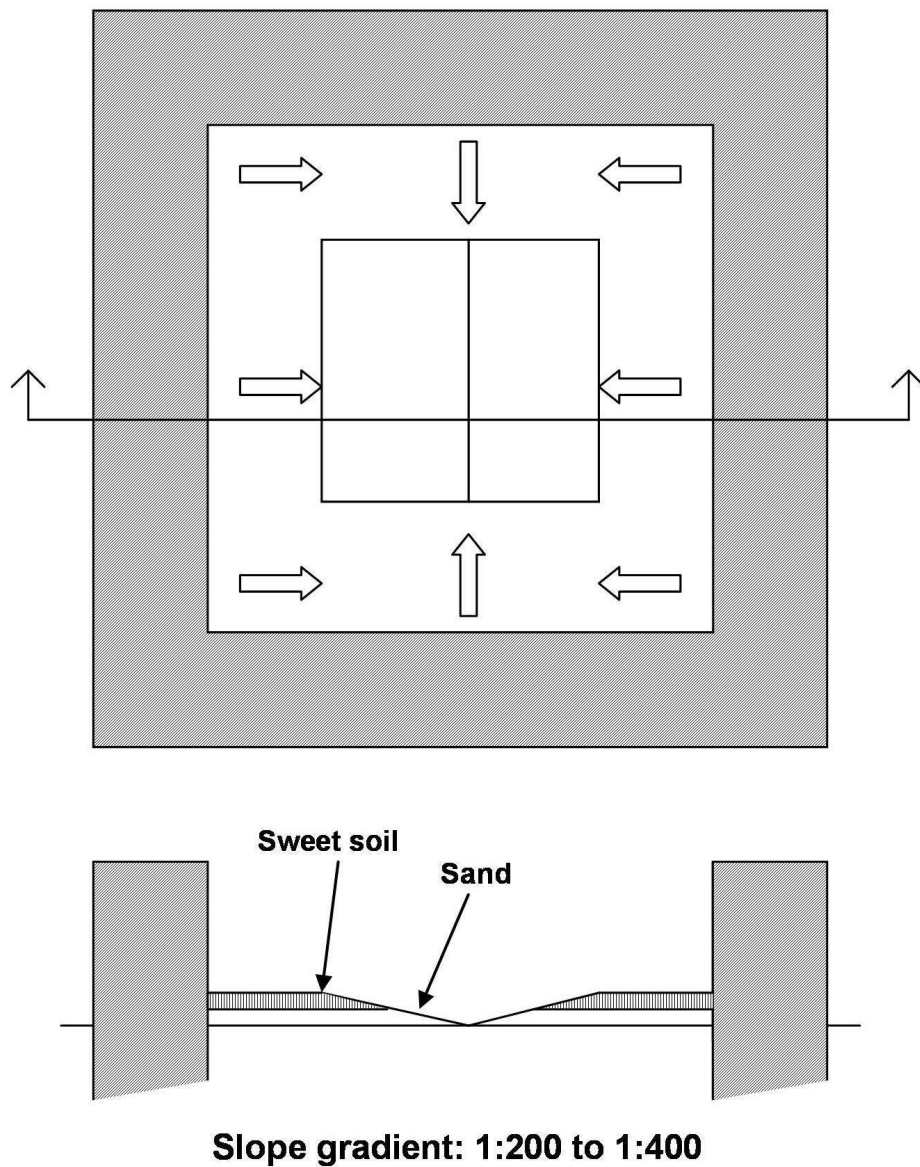
**Fig. 12. Schematic description of shallow ponding in plan and section**

Shallow ponding was created where water could not be diverted otherwise, especially in rooms with no door or exit. After removal of salty soil from the ground surface, the central portion of the room was cleaned from further debris so that to create a pond. Bunds were created where necessary in order to form a barrier against water. This was done by compacting sweet soil with a rammer so that to create a monolithic wall. Instead of building time-consuming mud brick *pushtas*, loose soil was rammed into layers until damp proof course level as barrier against water penetration and erosion. Figures 15-17 show a typical and representative room before and after emergency conservation work.

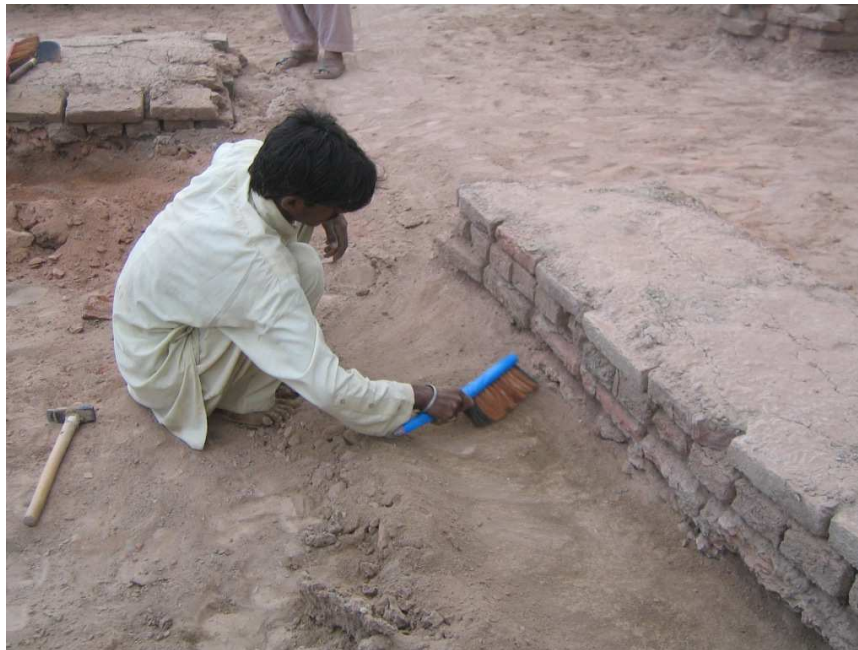
**Fig. 13 Removal and disposal of salty soil from the areas adjacent the walls is undertaken with a brush (DK-G South area)**

This was done with the help of a shovel and the portions of saline soil nearer to the walls were removed by means of brushes (Figure 13), so that to cause as little harm as possible to the bricks. The salty soil was accumulated in an area that could be reached by a tractor so that to allow easy disposal to a location outside the site boundary. Sweet soil was imported so that to improve drainage by creating sloping surfaces decreasing from the walls, and to allow water to be channeled towards the collector drain<sup>10</sup> (Figure 14).

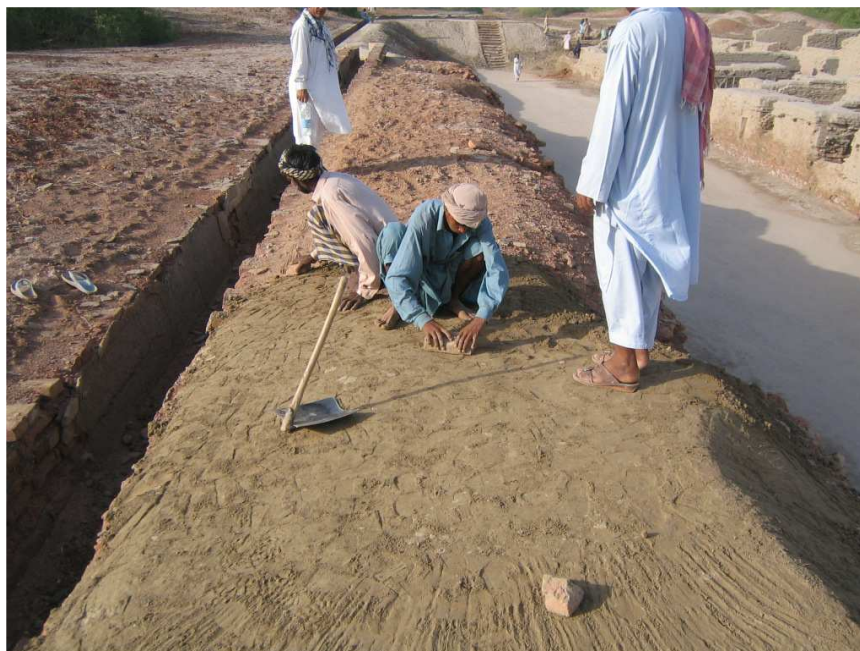
**Fig. 14 Sweet soil is rammed as protective layer before the monsoon precipitations. On the left hand side is a modern drainage channel running parallel to the wall (DK-G South area, First Street, top of eastern wall)**

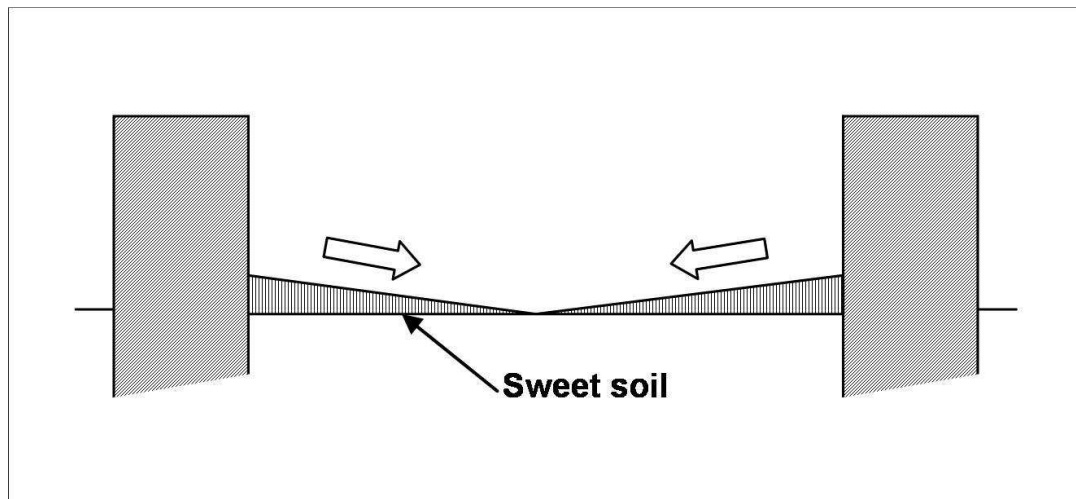
**Fig. 15 Schematic description of how water is channelled away from the archaeological remains with simple and affordable methods**

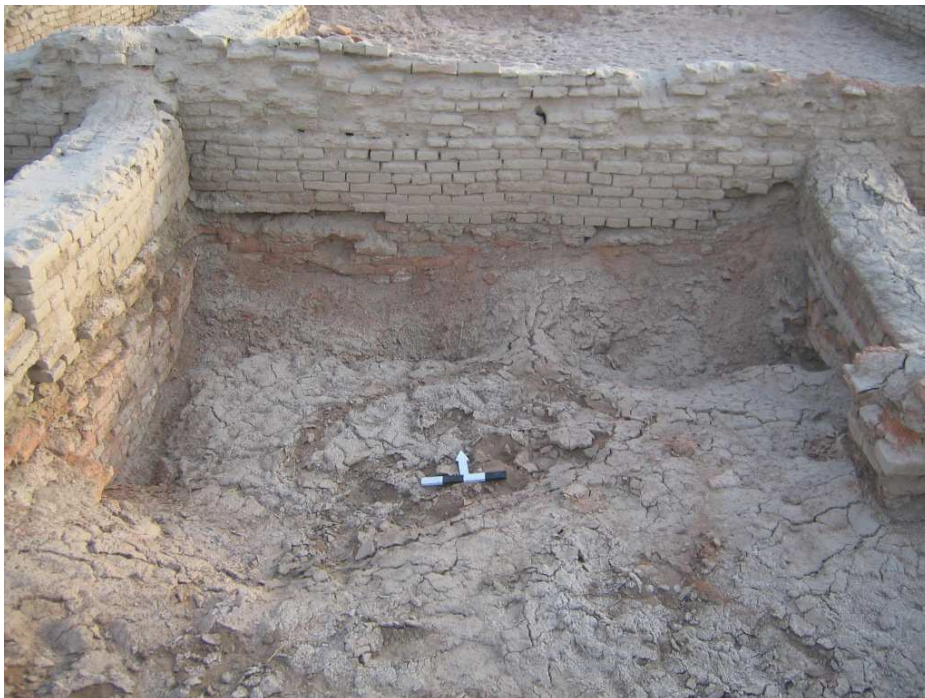
**Fig. 16 The picture shows the most endangered room of Moneer north before monsoon preparation work. An illegal excavation is visible on the left hand side and a gully on the right hand side (Moneer area, Block B, House VIII, Room 2, north view)**

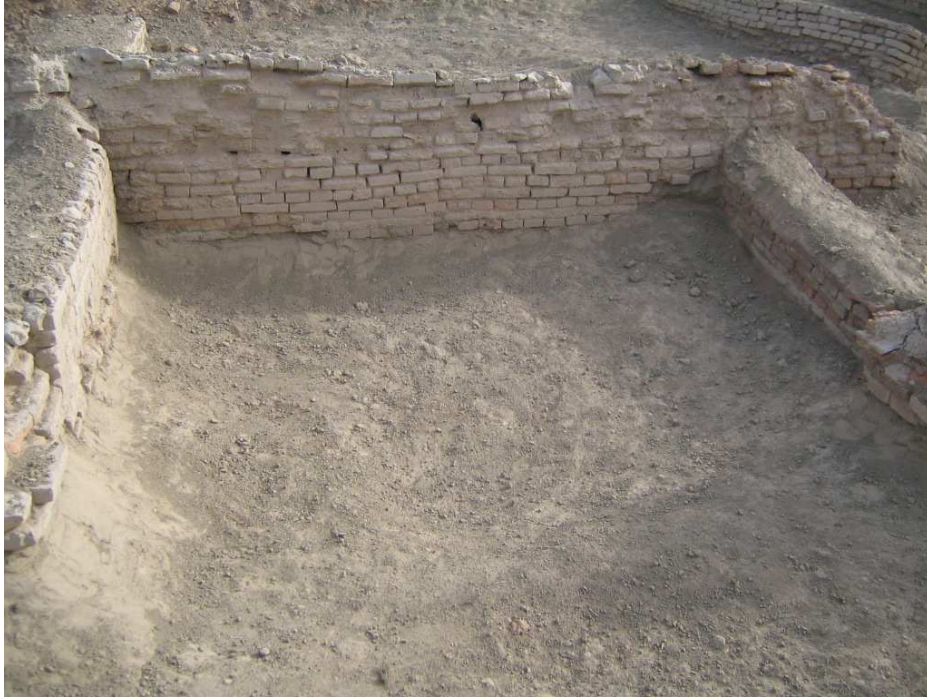
**Fig. 17 The picture shows the same room as in Figure 15 after monsoon preparation work. Water management was improved by replacing the salty soil and by adding a thick layer of sweet clay so that to create a shallow ponding (Moneer area, Block B, House VIII, Room 2, north view)**
